## Hypocapnia Caused by a Cracked Water Trap

Kenji Kayashima, Mika Kajita

Cite this article as: Kayashima K, Kajita M. Hypocapnia Caused by a Cracked Water Trap. Turk J Anaesthesiol Reanim 2017; 45: 320

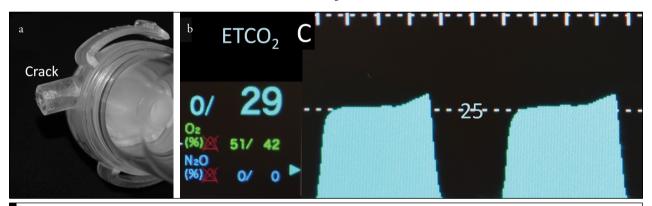
apnography is prone to equipment-related issues. Normal and abnormal capnograms arising from patients or equipment should be understood for identifying and resolving these issues. The increase at the end of the CO<sub>2</sub> waveform in the present case indicated a possible leak in the water trap. Our images revealed a problem in the Luer lock connection. Cracks may occur in various stages, highlighting that care should be taken regarding the deterioration of water trap connectors. In our experience, judging water trap deterioration from the CO<sub>2</sub> waveform seemed difficult, but it may be suspected when the capnogram shows an extremely low ETCO<sub>2</sub>.

Figure 1. A cracked water trap and a capnogram. After endotracheal intubation in a patient, the side stream-type capnogram showed 24 mmHg of end-tidal (ET) carbon dioxide ( $\rm CO_2$ ), whereas arterial blood gas sampling revealed an arterial partial pressures of  $\rm CO_2$  of 44.2 mmHg. A crack was found in the connector of the water trap (Figure 1a). A capnogram with the cracked water trap showed an  $\rm ETCO_2$  of 29 mmHg (Figure 1b) with an increase at the end of the  $\rm CO_2$  waveform

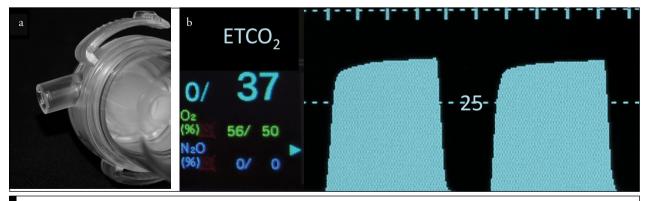
Figure 2. A normal water trap and capnogram. A capnogram obtained with a new water trap (Figure 2a) revealed a an ETCO, of 37 mmHg (Figure 2b)
